Re: Reconnaissance Inspection, April 23 and 25, 2012
Portions of the Quebrada San Antón, Quebrada Juan Méndez, Río Piedras River, Puerto Nuevo Canal, Quebrada Doña Ana watersheds
Municipality of San Juan ("MSJ") Municipal Separate Storm Sewer System ("MS4") Permit (PRR040036)
PRASA Puerto Nuevo Wastewater Treatment Plant Collection System (PR0021555)
Puerto Rico Department of Transportation and Public Works (DTOP) MS4 Permit PRR040080

**Compliance
Evaluation
Inspection:**

Municipality of San Juan Municipal Separate Storm Sewer System
("MS4") Permit (PRR040036)

Inspection Date: April 23 and 25, 2012

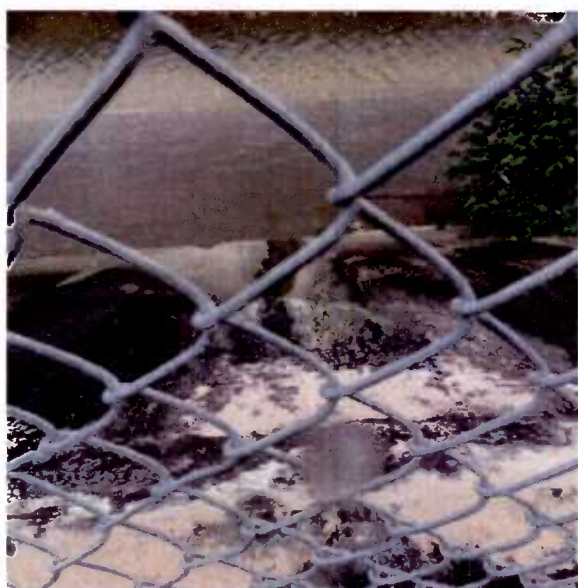
DSCN0009.JPG

DSCN0009	4/23/2012	Dry weather trickle into the Quebrada San Antón at Calle Hernández and Calle de La Torre (Just north of School).	San Juan
DSCN0010	4/23/2012	Dry weather trickle into the Quebrada San Antón at Calle Hernández and Calle de La Torre (Just north of School).	San Juan
DSCN0011	4/23/2012	Missing manhole cover at Calle Ledru and Calle Carlos de La Torre.	San Juan
DSCN0012	4/23/2012	Missing manhole cover at Calle Ledru and Calle Carlos de La Torre.	San Juan
DSCN0013	4/23/2012	Street sign at Calle Amalio Roldán and Calle Carlos de la Torre.	San Juan
DSCN0014	4/23/2012	Catch basin at or near Calle Amalio Roldán and Calle Carlos de la Torre.	San Juan
DSCN0015	4/23/2012	Outfall to Quebrada San Antón at or near Calle Amalio Roldán and Calle Carlos de la Torre.	San Juan
DSCN0016	4/23/2012	Outfall to Quebrada San Antón at or near Calle Amalio Roldán and Calle Carlos de la Torre.	San Juan
DSCN0020	4/23/2012	Dry weather discharge from pipe on southwest side of the Quebrada San Antón (San Juan) at Calle Antonio Luciano and Garcilaso De La Vega.	San Juan

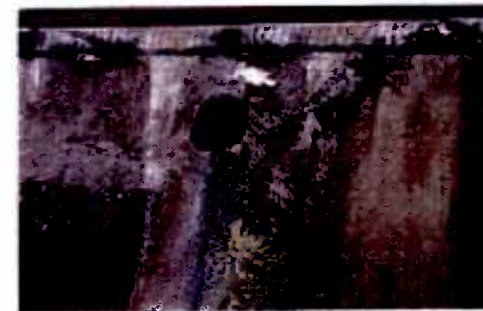
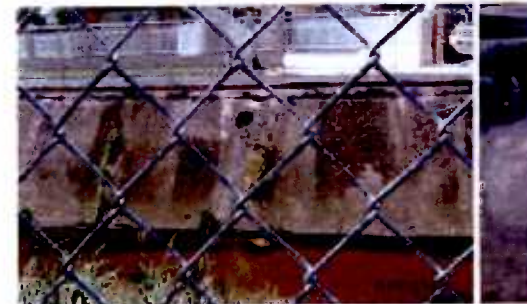
**(Att. 2a-5)Q15d-S006a, Quebrada San Anton, Sabana Llana Country
Club – Calle Belen Zequeira and Calle Carlos de la Torres
Outfall Reconnaissance Inventory Field Sheet**

VERIFICAR POSIBLE DESCARGA DE SISTEMA SANITARIO EN EL SISTEMA PLUVIAL DE SER ASI SE DEBE REALIZAR TRABAJOS PARA SEPARAR SISTEMAS

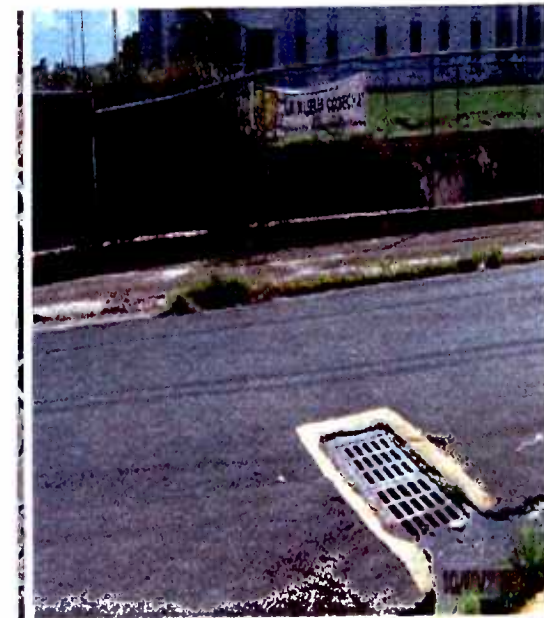
IMG_5082

As shown in photograph 20 there was a small dry weather discharge from this outfall at this location into Quebrada San Antón. Some algal growth was seen at this location. The CSA report in Attachment 2c-2 and 2c-3 recommended that the stormsewer system should be checked for possible sanitary connections.

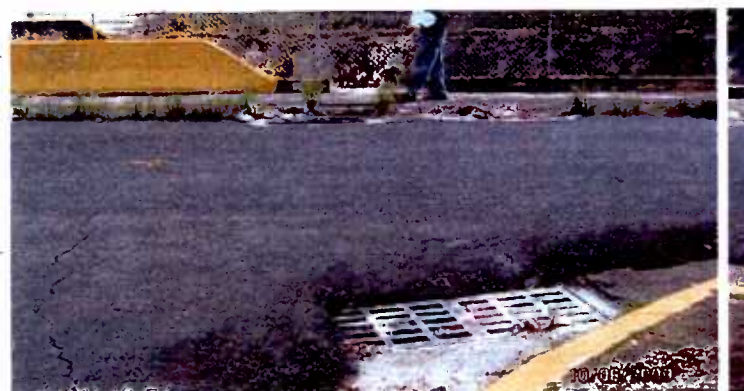
IMG_5087

As described in the CSA report attachments 2c-4 and 2c-5 CSA recommended that the stormsewer system should be checked for possible sanitary connections at this location. EPA did not list any findings from this location during this inspection, but MSJ should also inspect this outfall when it follows up on the other Quebrada San Antón discharges.

SE DEBE VERIFICAR POSIBLES DESCARGAS SANITARIA AL SISTEMA PLUVIAL
 DE SER ASI SE DEBE REALIZAR TRABAJOS PARA SEPARAR LOS
 SISTEMAS.

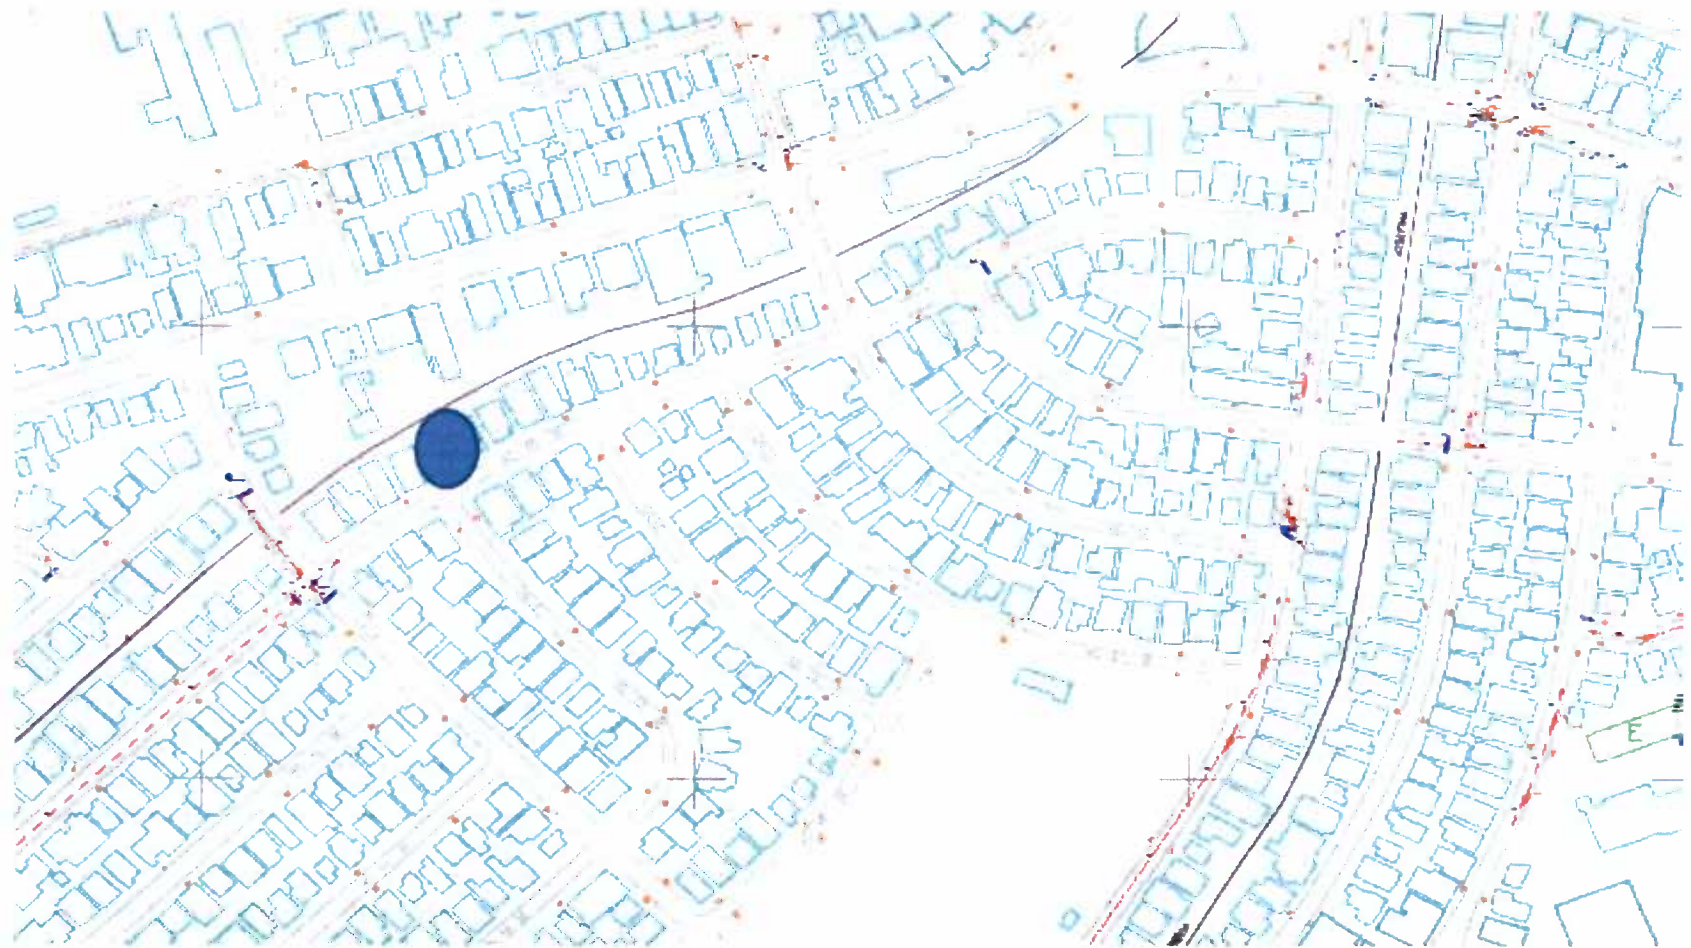
Approximate discharge location behind Kayak
Shop
